**Flood Control Project Maintenance
Levee Inspections**
LMA District Cover Sheet
Spring 2018 Levee Inspection Results

Reclamation District No. 0536 Egbert

Levee Inspection Report By Mile - Spring 2018

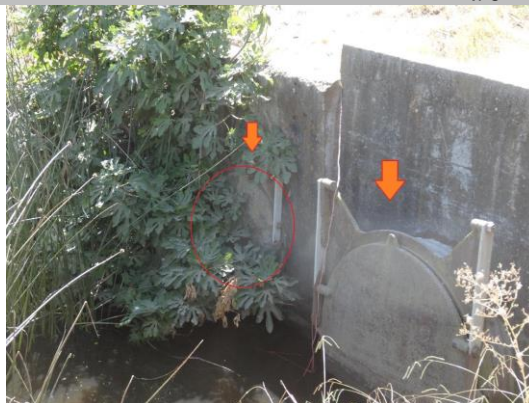
Photo 1 of 3 : UCIP_SP_2018_50161_34457.jpg

UCIP Comments: 06/01/2016: Holes and heavy corrosion inside pipe on WS have gotten worse. Flapgates appear in good condition though vegetation blocks view of flapgate for 36-inch on WS. These pipes are still in use and necessary for drainage; pipes may be eligible for repair under DWR Deferred Maintenance Program. (K. Fazel - UCIP)08/13/2013:- Holes in pipe outlet due to heavy corrosion.- Needs detailed investigation of the pipe.- Headwall cracked and tilted on WS. (P. Amatya - DWR)

WS view: two CMPs with flap gates. Concrete headwall supports the pipes. A 36" CMP (left) and 60" CMP (right).

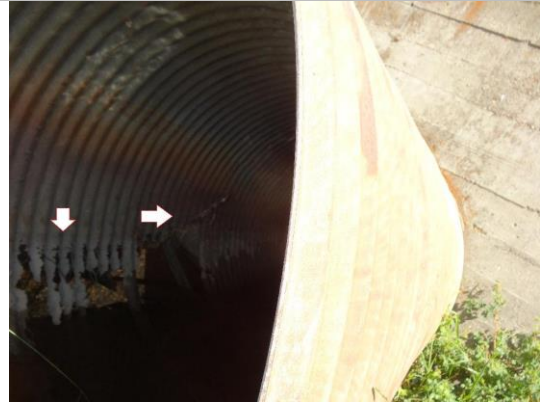
Photo 3 of 3 : UCIP_SP_2018_50161_34455.jpg

Comment Code						
Inspector Comment						
FS_ID:50161 DS_ID:22712 EP_NO: 10114 Repair Type: Urgent Crossing Status: Found UCIP Comments: 06/01/2016: Holes and heavy corrosion inside pipe on WS have gotten worse. Flapgates appear in good condition though vegetation blocks view of flapgate for 36-inch on WS. These pipes are still in use and necessary for drainage; pipes may be eligible for repair under DWR Deferred Maintenance Program. (K. Fazel - UCIP)08/13/2013:- Holes in pipe outlet due to heavy corrosion.- Needs detailed investigation of the pipe.- Headwall cracked and tilted on WS. (P. Amatya - DWR) FIELD_STRUCT_DESC: 1 of 2: 60-inch corrugated metal gravity drainage pipe through the levee, 10 feet below the crown. Flap gate on the waterside (WS). Headwall on each end. Culverts run under the road to provide drainage from agricultural fields via a landside (LS) ditch to Lindsey Slough. No. 100 gate in the LS drainage ditch. Reclamation District No. 536 (RD0536) president is David Hearn at hearnd5@gmail.com. (Retention of one 60-inch and one 36-inch drainage pipes through the levee, 10 feet and 6.5 feet below the crown, respectively, and flap gates on the WS ends authorized under Automatic Board Order (ABO) issued as Permit No. 10114, 1974 - H. E. Peterson). [Additional Reference(s): DWR Levee Log, 1992. USACE Sacramento O&M Manual 106, May 1953, (Station 294+49 ""A""), invert elevation 14.4 feet]. FS Date: 6/1/2016

LS view: holes & cracks on CM pipe due to heavy corrosion. Needs detailed investigation of the pipe.

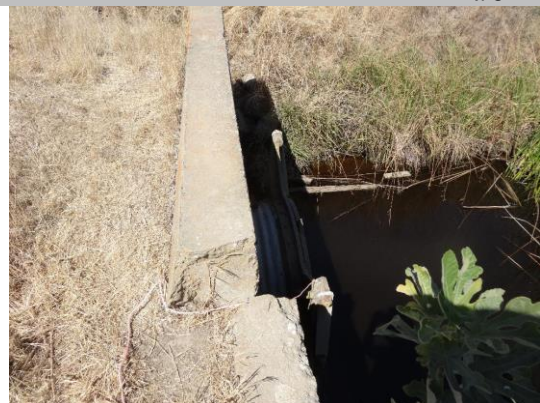
Photo 2 of 3 : UCIP_SP_2018_50160_34770.jpg

FS_ID:50160
DS_ID:22726
EP_NO: 10114
Repair Type: Urgent
Crossing Status: Found
UCIP Comments: 06/01/2016 Pipe is not abandoned. Though neglected, it is still functional and a needed system feature. Pipe is severely corroded with holes in it, which are visible on LS. Vegetation blocks view of flapgate on WS. Pipes may be eligible for repair under DWR Deferred Maintenance Program. (K. Fazel - UCIP)08/13/2013 This pipe seems to be abandoned. Headwall cracked and tilted on WS. (P. Amatya)
FIELD_STRUCT_DESC: 2 of 2: 36-inch corrugated metal gravity drainage pipe through the levee, 10 feet below the crown. Flap gate on the waterside (WS). Headwall on each end. Culverts run under the road to provide drainage from agricultural fields via a landside (LS) ditch to Lindsey Slough. No. 100 gate in the LS drainage ditch. Reclamation District No. 536 (RD0536) president is David Hearn at hearnd5@gmail.com. (Retention of one 60-inch and one 36-inch drainage pipes through the levee, 10 feet and 6.5 feet below the crown, respectively, and flap gates on the WS ends authorized under Automatic Board Order (ABO) issued as Permit No. 10114, 1974 - H. E. Peterson). [Additional Reference(s): DWR Levee Log, 1992, referenced as 6.5 feet below the crown. USACE Sacramento O&M Manual 106, May 1953, (Station 294+49 "A"), invert elevation 14.4 feet].

WS view: cracked and tilted concrete headwall.

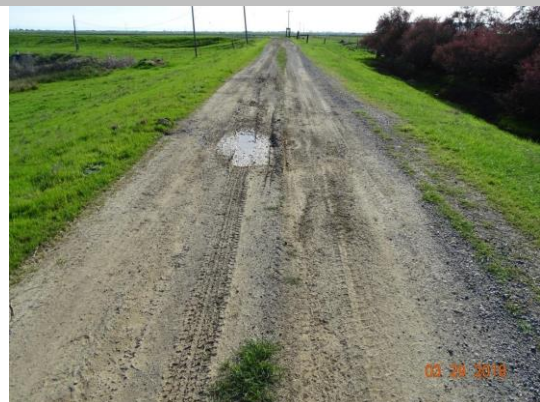
Photo 1 of 1 : SP_2018_RD0536_208_21_20180329_00060.jpg

LM Start	0.28	Rating **	M	Issue No.	21
LM End	0.37	Issue Type +	Ma	Location *	CR
Category	Earthen Levee			GPS Latitude/Longitude	
				Start	End
Item	Crown Surface / Depressions / Rutting			38.245602 °	38.245713 °
				-121.764047 °	-121.762449 °
DWR ID	DWR_RD0536_01_s_2017_21				
Comment Code					
C2 : Repair depressions or ruts in the crown or slope.					
Inspector Comment					
Crown rutting has been reduced by regrading and addition of base rock in RD536, but still exists in this area. Should be repaired.

Crown should be graded and surfaced with base rock.

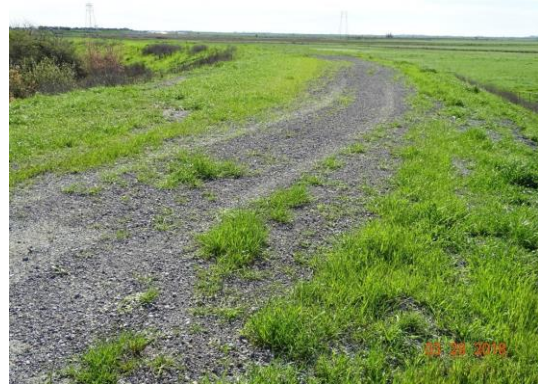
Photo 1 of 1 : SP_2018_RD0536_208_56_20180329_00061.jpg

LM Start	2.69	Rating **	A/W	Issue No.	56
LM End	2.71	Issue Type +	Ma	Location *	CR
Category	Earthen Levee			GPS Latitude/Longitude	
				Start	End
Item	Crown Surface / Depressions / Rutting			38.255197 °	38.254973 °
				-121.737932 °	-121.737577 °
DWR ID	DWR_RD0536_01_f_2014_56				
Comment Code					
C2 : Repair depressions or ruts in the crown or slope.					
Inspector Comment					
Possible subsidence in this area has been repaired. Grade was restored and base rock was added to crown. Area looks good on 3/29/18. Should continue to monitor this site for possible future subsidence.

3/29/2018: Crown rutting and possible subsidence has been repaired, but area should continue to be monitored for possible future subsidence.

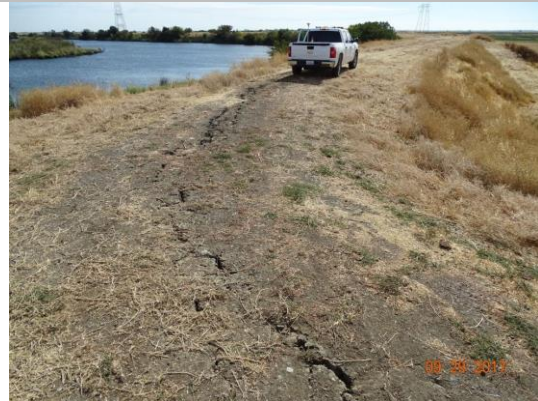
Photo 1 of 1 : SP_2018_RD0536_208_18_20180305_00004.jpg

LM Start	2.95	Rating **	A/W	Issue No.	18
LM End	2.95	Issue Type +	Ma	Location *	CR
Category	Earthen Levee			GPS Latitude/Longitude	
				Start	End
Item	Cracking			38.256047 °	38.256047 °
				-121.733728 °	-121.733728 °
DWR ID	DWR_RD0536_01_f_2017_18				
Comment Code					
CR1 : Monitor and have inspected by geotechnical engineer.					
Inspector Comment					
9/29/2017: Cracks in and along crown. Possible indicator of land side slumping. Cracks up to 6 inches wide and 2 feet deep. 3/29/2018: Crown has been graded and base rock added. No cracks visible. Area should continue to be monitored for future cracking.

09/29/2017: Cracks in crown.

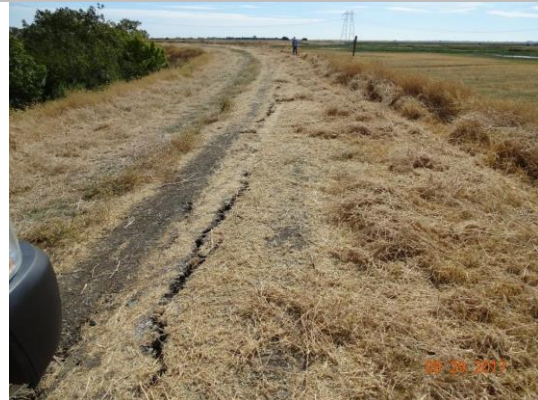
Photo 1 of 1 : SP_2018_RD0536_208_19_20180305_00006.jpg

LM Start	2.99	Rating **	A/W	Issue No.	19
LM End	3.00	Issue Type +	Ma	Location *	LS
Category	Earthen Levee			GPS Latitude/Longitude	
				Start	End
Item	Cracking			38.255581 °	38.255562 °
				-121.733117 °	-121.733085 °
DWR ID	DWR_RD0536_01_f_2017_19				
Comment Code					
CR2 : Schedule repair of subsidence prior to the next inspection.					
Inspector Comment					
9/29/2017: Cracking on crown indicating slumping on land side. Crack width up to 8 inches, vertical drop on land side 3 to 5 inches, depth up to 2 feet. 3/29/2018: Crown has been graded and base rock added. No cracks visible. Area should continue to be monitored for future cracking.

09/29/2017: Cracks in crown showing vertical offset with land side lower than most of crown.

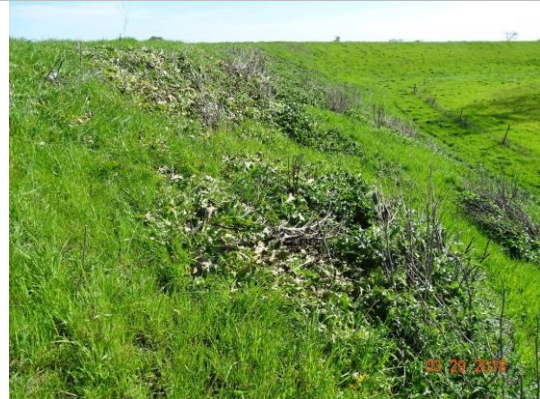
Photo 1 of 1 : SP_2018_RD0536_208_27_20180329_00062.jpg

Broad leaf veg hides slope; should be removed/managed.

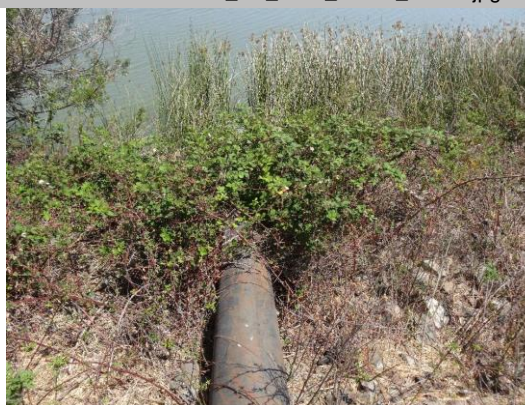
Photo 1 of 3 : UCIP_SP_2018_49314_34789.jpg

Comment Code						
Inspector Comment						
FS_ID:49314 DS_ID:24023 EP_NO: N/A Repair Type: Non-Urgent Crossing Status: Found UCIP Comments: 06/01/2016 Could not see flapgate in water. Pipes still in use. No cover over pressure relief valve on WS slope.08/13/2013:- Field discovered pipe.- Needs more information from the LMA/ DWR Inspector. - Dense vegetation on WS.- Pump feeds both pipes. FIELD_STRUCT_DESC: 2 of 2: 18-inch steel drainage discharge pipe through the levee, approximately 4 feet below the crown. Pump, called the Buddha Pump, in a pump house on the landside (LS) at the drainage ditch. Pressure breaker on the waterside (WS) slope. Pump and pipes are used by Reclamation District No. 536 (RD0536), per district president David Hearn, but could not identify permit information. Landowner is Dan Hearn per Solano County Assessor's Office (Parcel No. 0042-180-220). FS Date: 6/1/2016

WS view: exposed 18" steel pipe on levee slope.

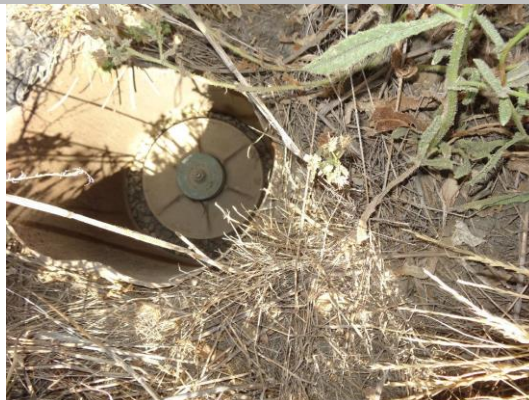
Photo 2 of 3 : UCIP_SP_2018_20563_34645.jpg

WS view: uncovered siphon breaker on levee shoulder. It needs protection.

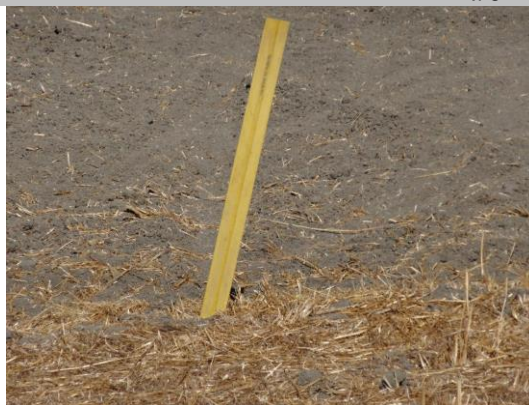
Photo 2 of 3 : UCIP_SP_2018_20664_34745.jpg

WS view: closer look at gasline indicator. The indicator is different than standard indicators.
